# Property Claims

## Subrogation: A Roofer Ruins a Home

The project was a two-story, wood-framed, single-family residence with a tile roof and stucco exterior walls, originally constructed in the 1970s. The home became the subject of a significant insurance claim after subcontracted repairs led to a catastrophic structural failure.

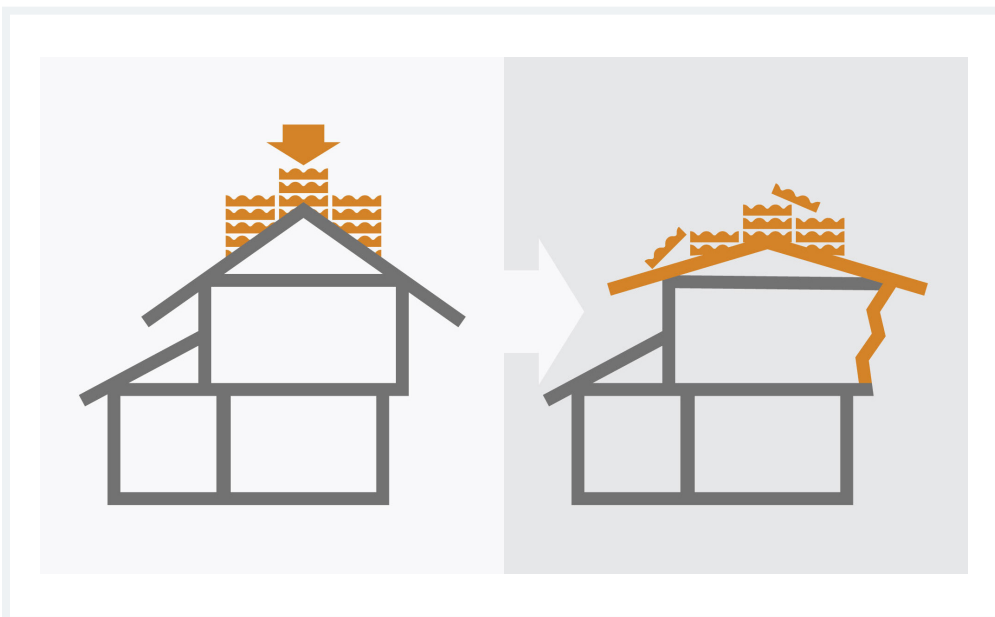
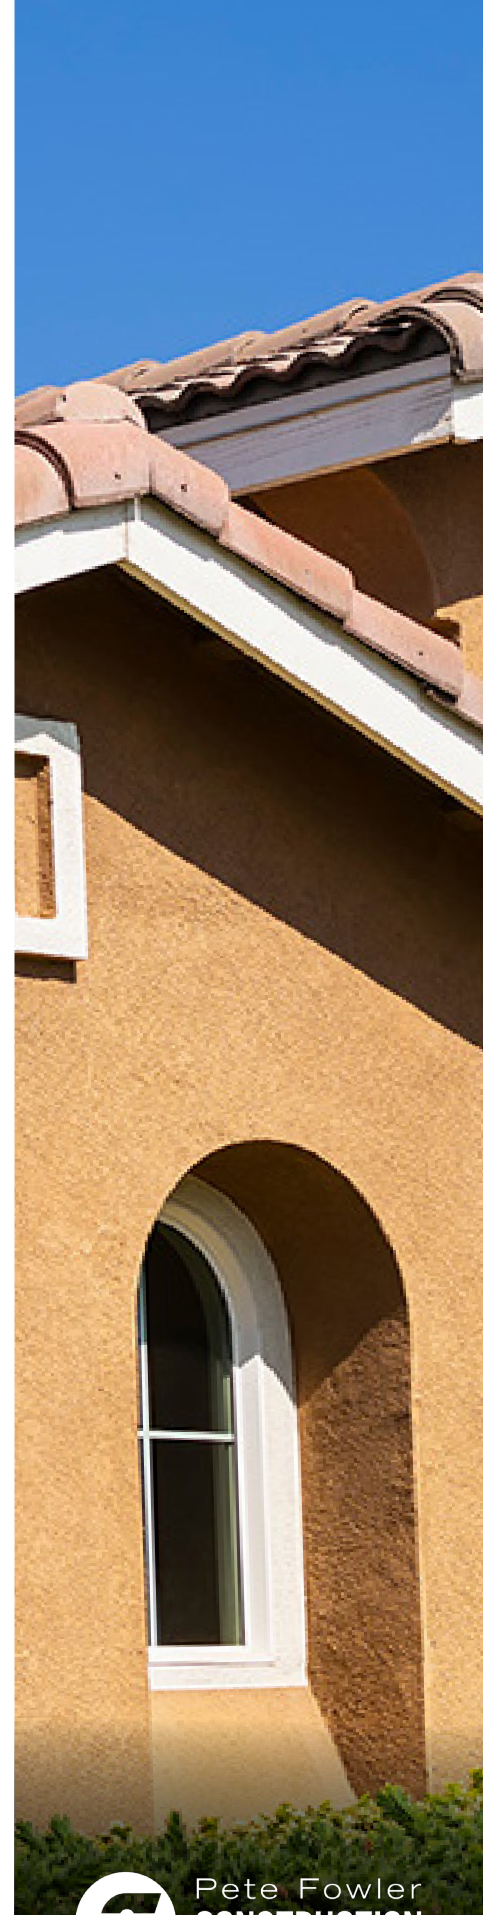
The roofing crew created stacks that were 16 to 20 tiles high, resulting in concentrated point-loads exceeding 200 pounds per stack. While the owners were home and working in their respective offices, the roof structure succumbed to the massive weight and spectacularly collapsed. This caused significant structural damage to the roof framing, exterior walls, and interior ceilings.

Our team performed a visual site inspection to document the structural failures. We observed that the second-story exterior wall was leaning out of plumb by approximately 16 inches, and the ceiling joists had pulled completely away from the wall framing.
