# Investigating Water Intrusion Claims

Pete Fowler  
**CONSTRUCTION**  
Services, Inc.

Forensic experts from Pete Fowler Construction Services, Inc. will explain the various components of a building envelope that can allow water to intrude into the interior. More importantly, they will explain the methods experts use to isolate the point(s) of entry.

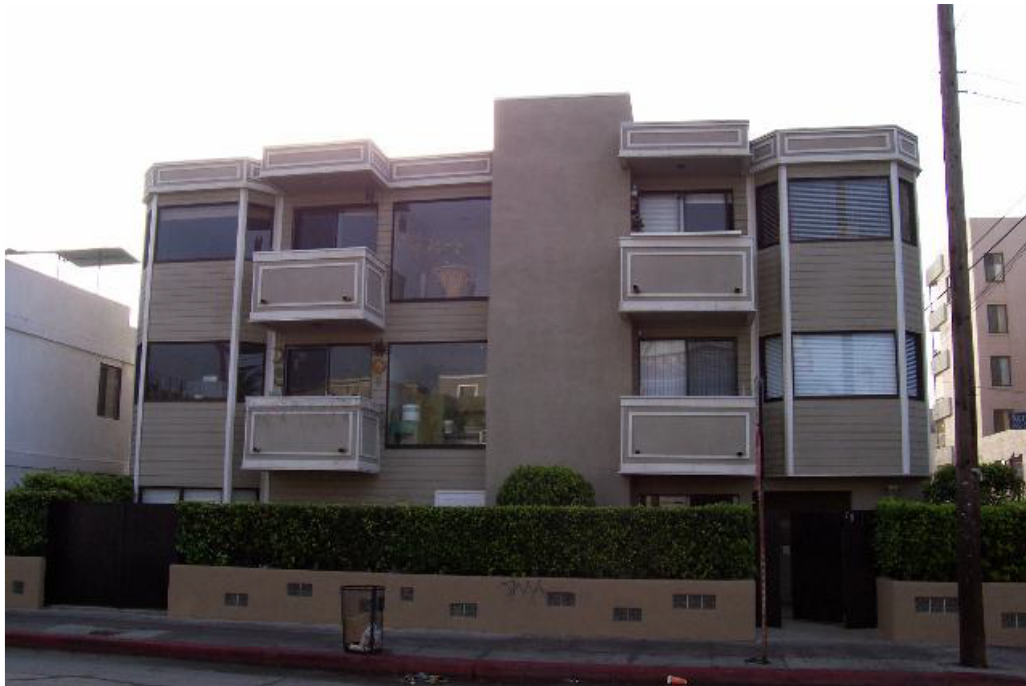
PF 01.006 PF 01- 006.jpg

Front elevation: [REDACTED] front elevation shot. Three floors (above grade), flat roof, wood siding and stucco walls. There are four balcony decks on front elevation, each with two scuppers.

The project is a 3-level, 4-unit condominium building near the beach in [REDACTED] constructed around 1988-89. The building occupies the entire lot except for minimum set-backs (5 to 10-feet) at all four elevations. Level 1 consists of individual parking garages accessed at the back elevation, storage rooms, a studio and an entry foyer to access the elevator to the second floor (Units A and B or 1 and 2) and the third floor (Units C and D or 3 and 4). The building has a low slope roof, roof-top deck areas, wood siding and stucco exterior building walls, and a slab-on-grade foundation. There are four balcony decks on front and four on the back elevations.

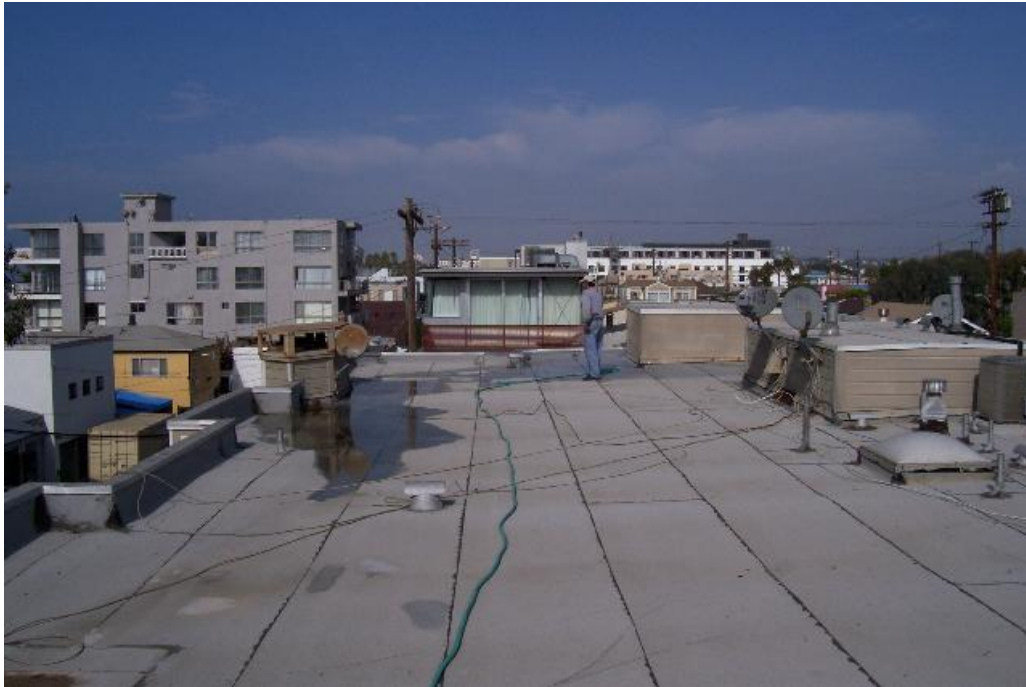
PF 01.133 PF 01- 133.jpg Roof: General shot.

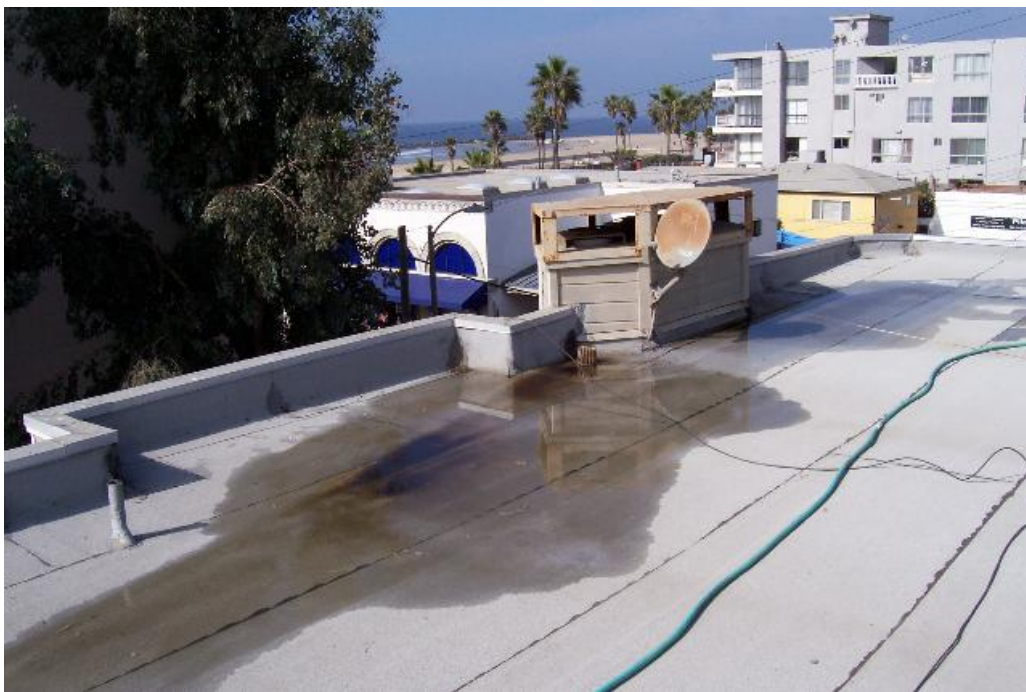
PF 01.135 PF 01- 135.jpg Roof test A: water is ponding around drain at right elevation near chimney.

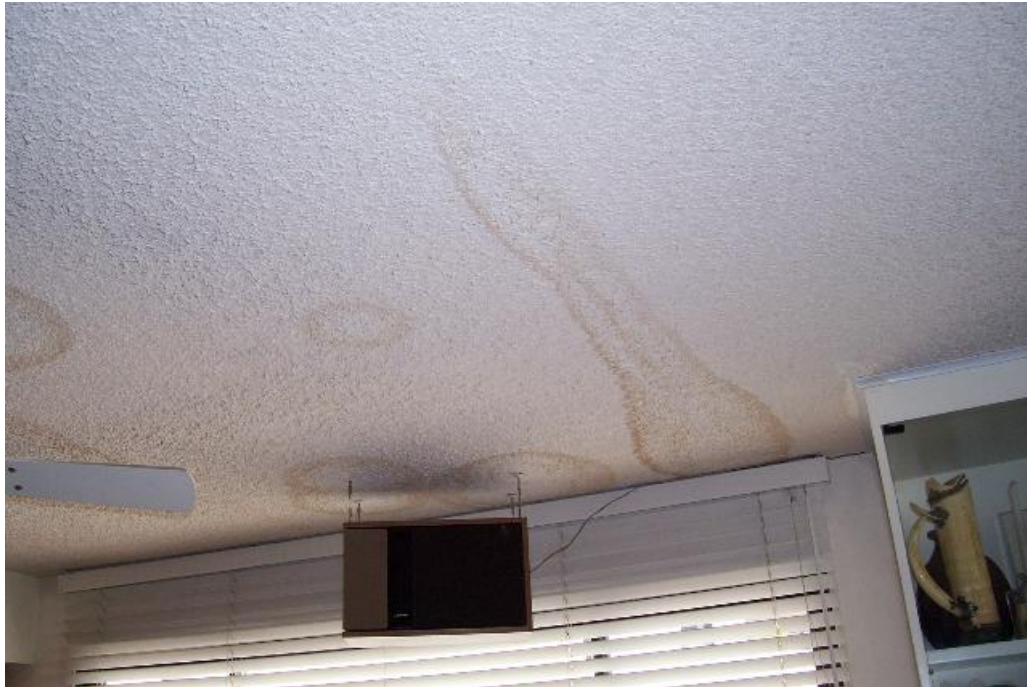
PF 01.070 PF 01- 070.jpg Unit C dining room: Ceiling stains surrounding ceiling fan and above speaker. The floor is concrete.

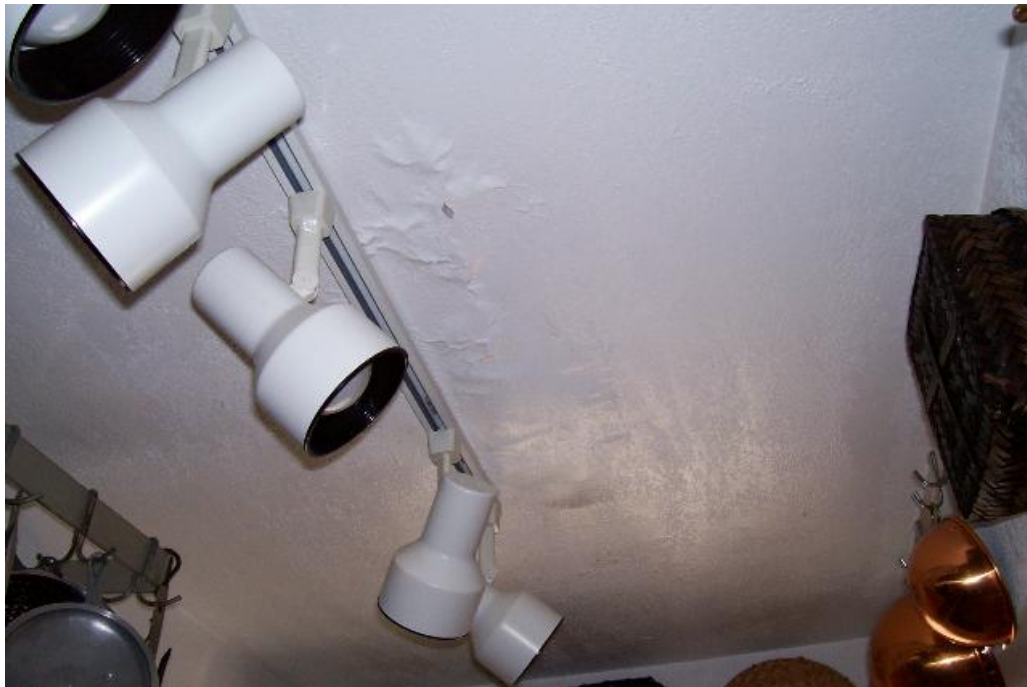
PF 01.083 PF 01- 083.jpg Unit C kitchen: Ceiling damage.

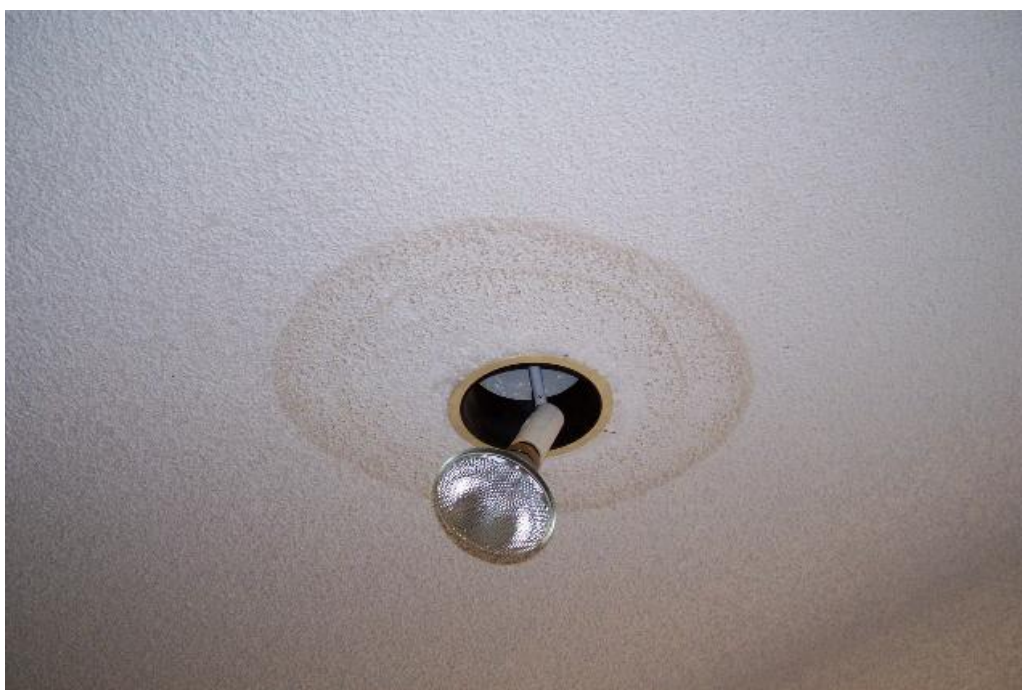
PF 01.097 PF 01- 097.jpg Unit C bedroom #2: ceiling stain at can light in center of room, at back and front.
